PRELIMINARY ARBORICULTURAL ASSESSMENT

133 and 135 Gower Street, Preston, 3072

Owner:	Ecology & Restoration Australia Pty Ltd
Date:	27 July 2023
Author/s:	Chris White BSc (Env)(Hons) Ph 0401 483 141 E- chris.w@eraus.com.au

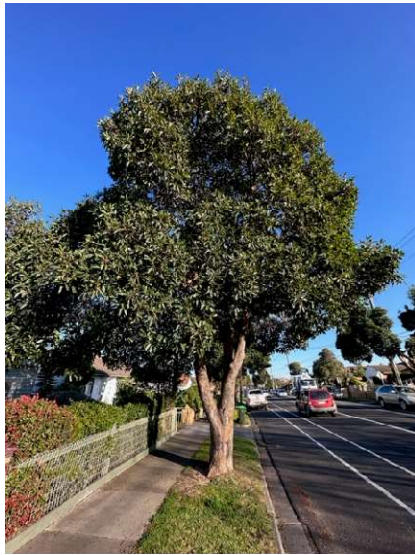
TREE #	1

SPECIES	<i>Lophostemon confertus</i>			
COMMON NAME	Queensland Brush Box			
TYPE	Non-indigenous Native			
DBH (CM)	53			
HEIGHT (M)	9			
SPREAD (M)	10			
STRUCTURE	Good			
HEALTH	Good			
AGE	Mature			
AMENITY VALUE	Medium			
ULE (YRS)	15-40	TPZ (M)	6.4	
NOTES	Street tree growing ~4.5 metres from the crossover of 133 Gower Street. Co-dominant primary union from 1.4 metres height- union appears sound. Past removal of some lower branches for street clearance.			
IMPACT	TBC			
RECOMMENDATIONS	Erect TPZ fencing surrounding this tree to protect it from development related impacts. The fencing should remain within the bounds of the nature strip and not impede pedestrian or vehicle traffic.

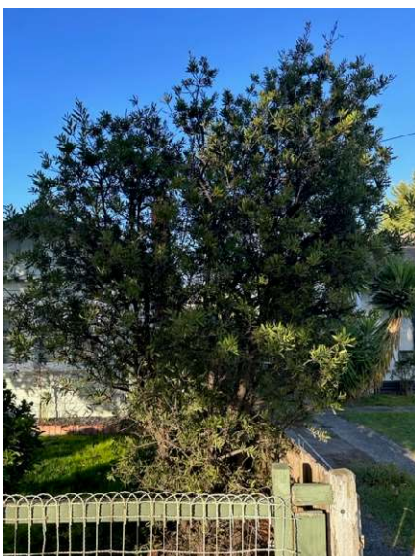
TREE #	2

SPECIES	Calistemon sp			
COMMON NAME	Bottlebrush			
TYPE	Non-indigenous Native			
DBH (CM)	<10			
HEIGHT (M)	5			
SPREAD (M)	3			
STRUCTURE	Good			
HEALTH	Good			
AGE	Mature			
AMENITY VALUE	Low			
ULE (YRS)	15-40	TPZ (M)	2.0	
NOTES	Tree growing 0.5 metres from the fence line on the property to the east of the subject site			
IMPACT	TBC

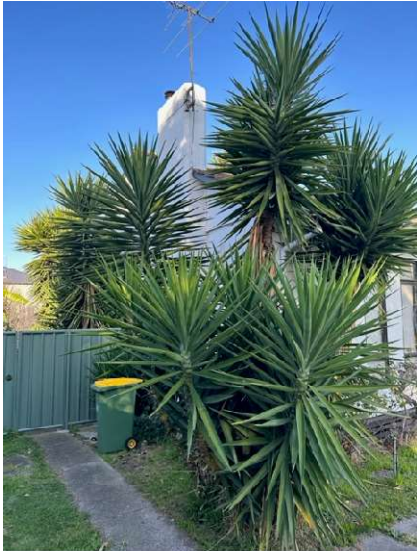
TREE #	4 (x 5)

SPECIES	<i>Yucca elephantipes</i>			
COMMON NAME	Spineless Yucca			
TYPE	Exotic			
DBH (CM)	25			
HEIGHT (M)	6			
SPREAD (M)	5			
STRUCTURE	Good			
HEALTH	Good			
AGE	Mature			
AMENITY VALUE	Low			
ULE (YRS)	15-40	TPZ (M)	3.0	
IMPACT	TBC

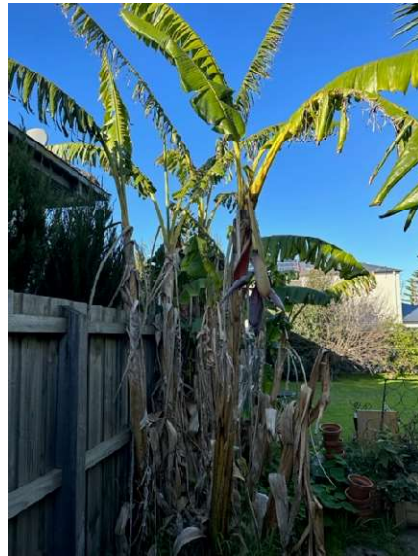
TREE #	5		
SPECIES	<i>Musa sp</i>		
COMMON NAME	Banana		
TYPE	Exotic		
DBH (CM)	N/A		
HEIGHT (M)	7		
SPREAD (M)	5		
STRUCTURE	Good		
HEALTH	Good		
AGE	Mature		
AMENITY VALUE	Low		
ULE (YRS)	15-40	TPZ (M)	3.5
IMPACT	TBC

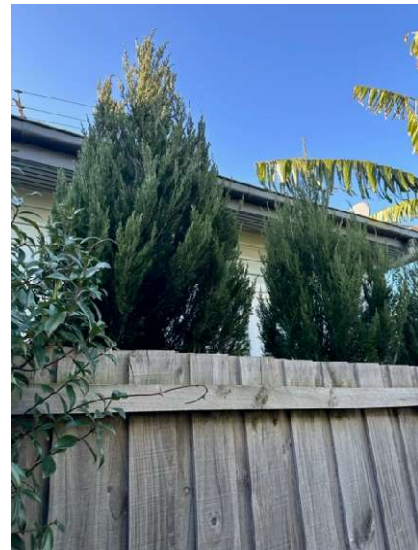
TREE #	6 (x 7)		
SPECIES	<i>Cupressus sempervirens</i>		
COMMON NAME	Italian Cypress		
TYPE	Exotic		
DBH (CM)	~15		
HEIGHT (M)	5		
SPREAD (M)	1		
STRUCTURE	Good		
HEALTH	Good		
AGE	Juvenile		
AMENITY VALUE	Low		
ULE (YRS)	15-40	TPZ (M)	2.0
NOTES	Group of 7 trees planted 0.3 metres from the fence line on the property to the east of the subject site		
IMPACT	TBC

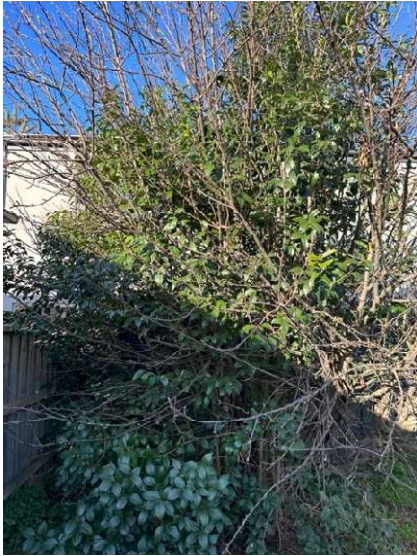
TREE #	7

SPECIES	<i>Ligustrum lucidum</i>			
COMMON NAME	Broad-leaf Privet			
TYPE	Exotic			
DBH (CM)	<10			
HEIGHT (M)	5			
SPREAD (M)	4			
STRUCTURE	Good			
HEALTH	Good			
AGE	Juvenile			
AMENITY VALUE	Low			
ULE (YRS)	5-15	TPZ (M)	2.0	
NOTES	Multi-stemmed from ground level- union appears sound			
IMPACT	TBC

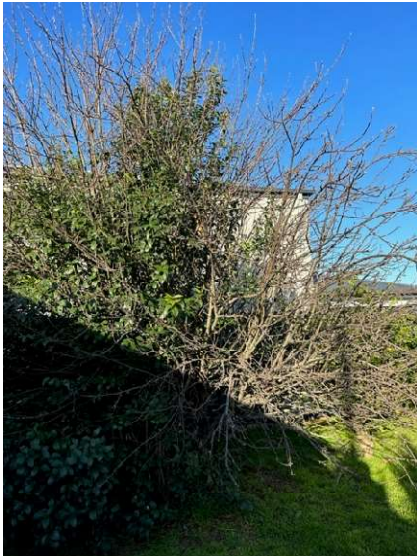
TREE #	8

SPECIES	<i>Prunus</i> sp			
COMMON NAME	Plum			
TYPE	Exotic			
DBH (CM)	27			
HEIGHT (M)	7			
SPREAD (M)	6			
STRUCTURE	Good			
HEALTH	Good			
AGE	Mature			
AMENITY VALUE	Low			
ULE (YRS)	15-40	TPZ (M)	3.2	
NOTES	Co-dominant primary union from near ground- union appears sound			
IMPACT	TBC

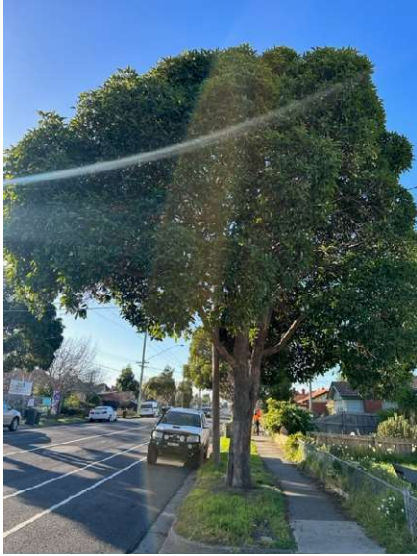
TREE #	9

SPECIES	<i>Lophostemon confertus</i>			
COMMON NAME	Queensland Brush Box			
TYPE	Non-indigenous Native			
DBH (CM)	48			
HEIGHT (M)	10			
SPREAD (M)	9			
STRUCTURE	Good			
HEALTH	Good			
AGE	Mature			
AMENITY VALUE	Medium			
ULE (YRS)	15-40	TPZ (M)	5.8	
NOTES	Street tree growing ~2 metres from the subject site. Co-dominant primary union from 2 metres height- union appears sound. Pruning of central crown for powerline clearance.			
IMPACT	TBC			
RECOMMENDATIONS	Erect TPZ fencing surrounding this tree to protect IT from development related impacts. The fencing should remain within the bounds of the nature strip and not impede pedestrian or vehicle traffic.

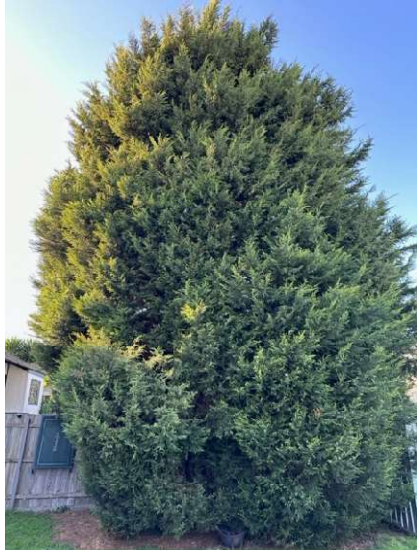
TREE #	10

SPECIES	<i>Hesperocyparis macrocarpa</i>			
COMMON NAME	Monterey Cypress			
TYPE	Exotic			
DBH (CM)	~45			
HEIGHT (M)	11			
SPREAD (M)	9			
STRUCTURE	Good			
HEALTH	Good			
AGE	Mature			
AMENITY VALUE	Medium			
ULE (YRS)	40+	TPZ (M)	5.4	
IMPACT	TBC

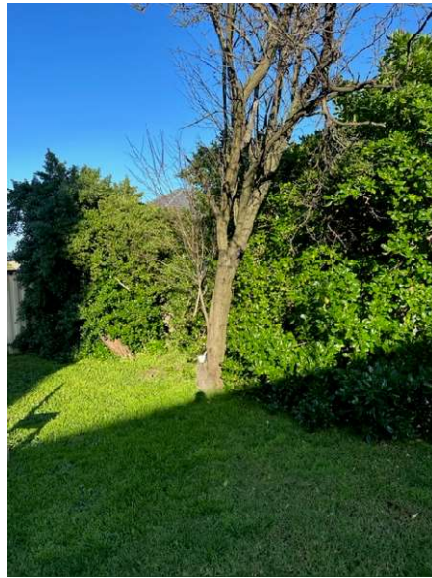
TREE #	11 (x 2)		
SPECIES	<i>Coprosma repens</i>		
COMMON NAME	New Zealand Mirror Bush		
TYPE	Exotic		
DBH (CM)	~20		
HEIGHT (M)	5		
SPREAD (M)	6		
STRUCTURE	Good		
HEALTH	Good		
AGE	Mature		
AMENITY VALUE	Low		
ULE (YRS)	15-40	TPZ (M)	2.4
IMPACT	TBC

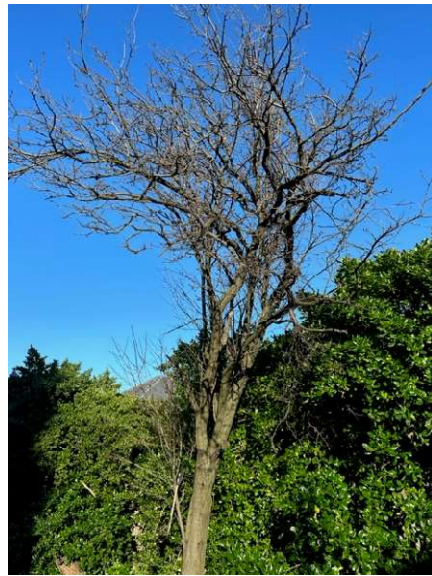
TREE #	12		
SPECIES	<i>Prunus sp</i>		
COMMON NAME	Plum		
TYPE	Exotic		
DBH (CM)	24		
HEIGHT (M)	8		
SPREAD (M)	6		
STRUCTURE	Fair		
HEALTH	Good		
AGE	Mature		
AMENITY VALUE	Low		
ULE (YRS)	15-40	TPZ (M)	2.9
IMPACT	TBC

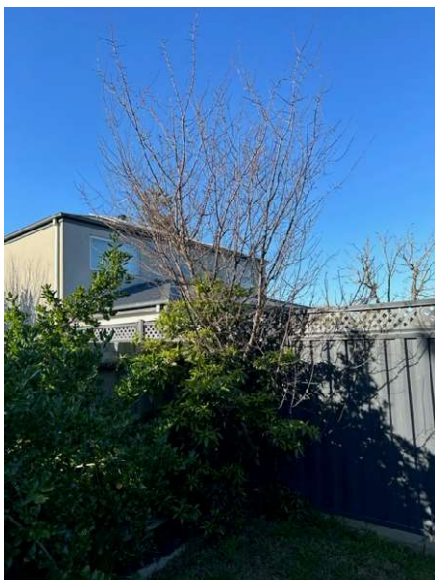
TREE #	13

SPECIES	Prunus sp			
COMMON NAME	Plum			
TYPE	Exotic			
DBH (CM)	<10			
HEIGHT (M)	6			
SPREAD (M)	4			
STRUCTURE	Good			
HEALTH	Good			
AGE	Juvenile			
AMENITY VALUE	Low			
ULE (YRS)	15-40	TPZ (M)	2.0	
IMPACT	TBC
