## ARBORICULTURAL IMPACT ASSESSMENT

133 Gower Street, Preston, 3072

Owner:	Ecology & Restoration Australia Pty Ltd
Date:	31 July 2024
Author/s:	Chris White BSc (Env)(Hons) Ph 0401 483 141 E- chris.w@eraus.com.au

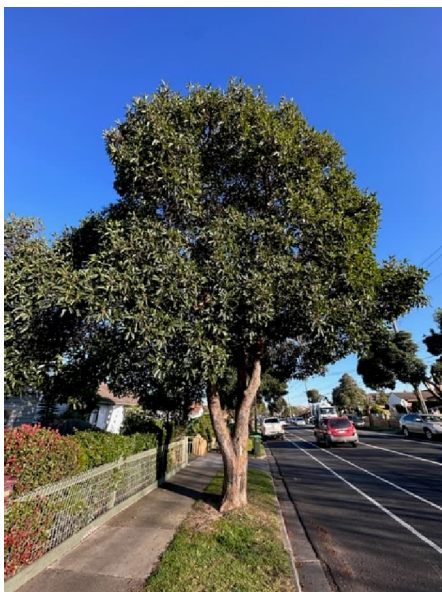
TREE #	1

SPECIES	<i>Lophostemon confertus</i>			
COMMON NAME	Queensland Brush Box			
TYPE	Non-indigenous Native			
DBH (CM)	53			
HEIGHT (M)	9			
SPREAD (M)	10			
STRUCTURE	Good			
HEALTH	Good			
AGE	Mature			
AMENITY VALUE	Medium			
ULE (YRS)	15-40	TPZ (M)	6.4	
NOTES	Street tree growing ~4.5 metres from the crossover of the site. Co-dominant primary union from 1.4 metres height- union appears sound. Past removal of some lower branches for street clearance.			
IMPACT	Low- the proposed works will not increase the encroachment beyond the existing conditions			
RECOMMENDATIONS	Erect TPZ fencing surrounding this tree to protect it from development related impacts. The fencing should remain within the bounds of the nature strip and not impede pedestrian or vehicle traffic.

- Tree 1 and 3- TPZ fencing must be erected around these trees to protect them from development related impacts. The fencing should remain within the bounds of the nature strip and not impede pedestrian or vehicle traffic.

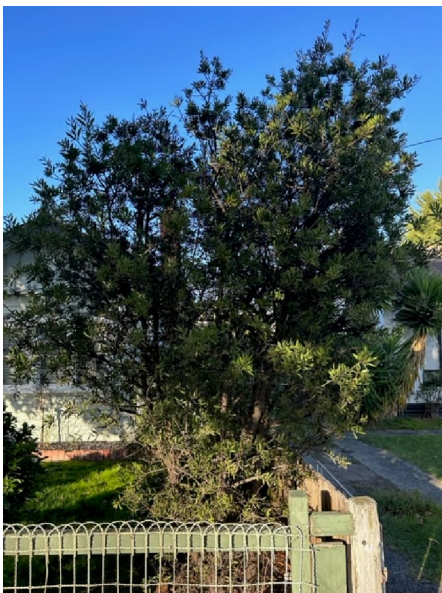
TREE #	2

SPECIES	<i>Calistemon</i> sp			
COMMON NAME	Bottlebrush			
TYPE	Non-indigenous Native			
DBH (CM)	<10			
HEIGHT (M)	5			
SPREAD (M)	3			
STRUCTURE	Good			
HEALTH	Good			
AGE	Mature			
AMENITY VALUE	Low			
ULE (YRS)	15-40	TPZ (M)	2.0	
NOTES	Tree growing 0.5 metres from the fence line on the property to the east of the subject site			
IMPACT	Low- the proposed works will not increase the encroachment beyond the existing conditions

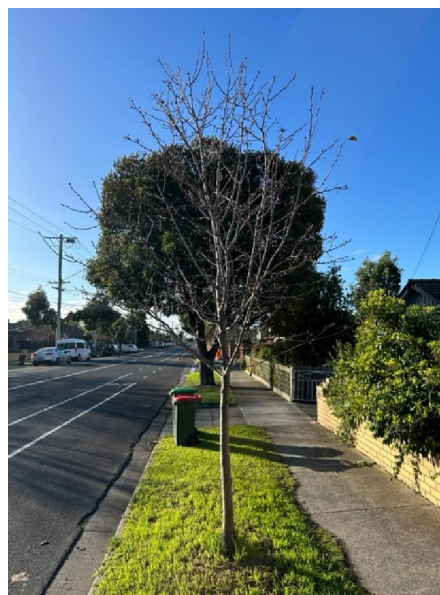
TREE #	3		
SPECIES	<i>Melia azedarach</i>		
COMMON NAME	White Cedar?		
TYPE	Non-indigenous Native		
DBH (CM)	<10		
HEIGHT (M)	5		
SPREAD (M)	3		
STRUCTURE	Good		
HEALTH	Good		
AGE	Juvenile		
AMENITY VALUE	Low		
ULE (YRS)	15-40	TPZ (M)	2.0
NOTES	Street tree growing ~2 metres from the subject site in the road reserve of Gower Street. No diagnostic material for accurate identification. Recently planted.		
IMPACT	Low- all works are outside the TPZ of this tree		
RECOMMENDATIONS	Erect TPZ fencing surrounding this tree to protect it from development related impacts. The fencing should remain within the bounds of the nature strip and not impede pedestrian or vehicle traffic.

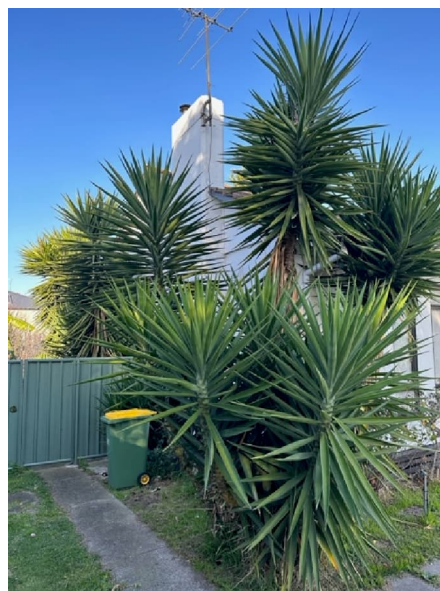
TREE #	4 (x 5)		
SPECIES	<i>Yucca elephantipes</i>		
COMMON NAME	Spineless Yucca		
TYPE	Exotic		
DBH (CM)	25		
HEIGHT (M)	6		
SPREAD (M)	5		
STRUCTURE	Good		
HEALTH	Good		
AGE	Mature		
AMENITY VALUE	Low		
ULE (YRS)	15-40	TPZ (M)	3.0
IMPACT	High- all plants proposed to be removed for the development.

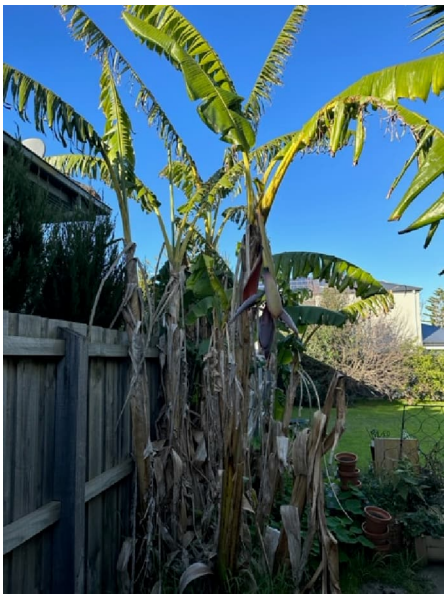
TREE #	5		
SPECIES	<i>Musa sp</i>		
COMMON NAME	Banana		
TYPE	Exotic		
DBH (CM)	N/A		
HEIGHT (M)	7		
SPREAD (M)	5		
STRUCTURE	Good		
HEALTH	Good		
AGE	Mature		
AMENITY VALUE	Low		
ULE (YRS)	15-40	TPZ (M)	3.5
IMPACT	High- plant proposed to be removed for the development.

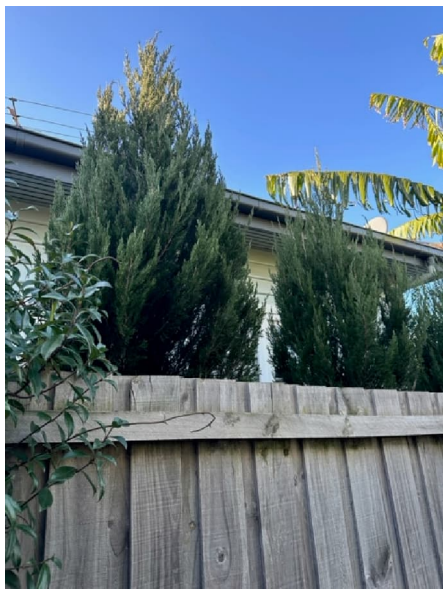
TREE #	6 (x 7)		
SPECIES	<i>Cupressus sempervirens</i>		
COMMON NAME	Italian Cypress		
TYPE	Exotic		
DBH (CM)	~15		
HEIGHT (M)	5		
SPREAD (M)	1		
STRUCTURE	Good		
HEALTH	Good		
AGE	Juvenile		
AMENITY VALUE	Low		
ULE (YRS)	15-40	TPZ (M)	2.0
NOTES	Group of 7 trees planted 0.3 metres from the fence line on the property to the east of the subject site		
IMPACT	Low- proposed development will result in a minor (5.6%) encroachment into the TPZ of these trees

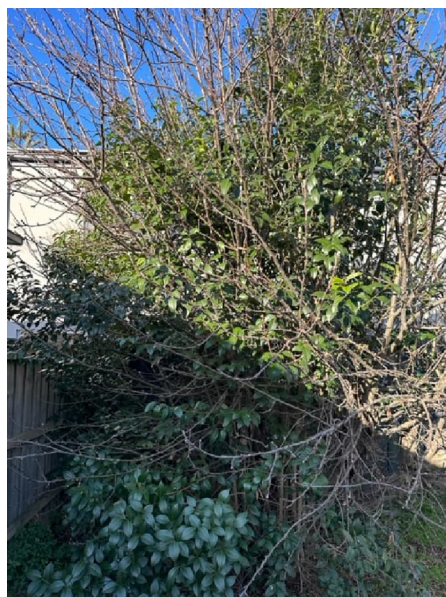
TREE #	7

SPECIES	<i>Ligustrum lucidum</i>			
COMMON NAME	Broad-leaf Privet			
TYPE	Exotic			
DBH (CM)	<10			
HEIGHT (M)	5			
SPREAD (M)	4			
STRUCTURE	Good			
HEALTH	Good			
AGE	Juvenile			
AMENITY VALUE	Low			
ULE (YRS)	5-15	TPZ (M)	2.0	
NOTES	Multi-stemmed from ground level- union appears sound			
IMPACT	High- tree proposed to be removed for the development

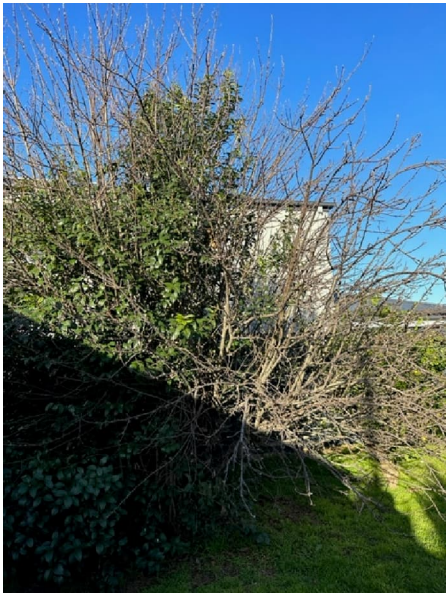
TREE #	8

SPECIES	<i>Prunus</i> sp			
COMMON NAME	Plum			
TYPE	Exotic			
DBH (CM)	27			
HEIGHT (M)	7			
SPREAD (M)	6			
STRUCTURE	Good			
HEALTH	Good			
AGE	Mature			
AMENITY VALUE	Low			
ULE (YRS)	15-40	TPZ (M)	3.2	
NOTES	Co-dominant primary union from near ground- union appears sound			
IMPACT	High- tree proposed to be removed for the development

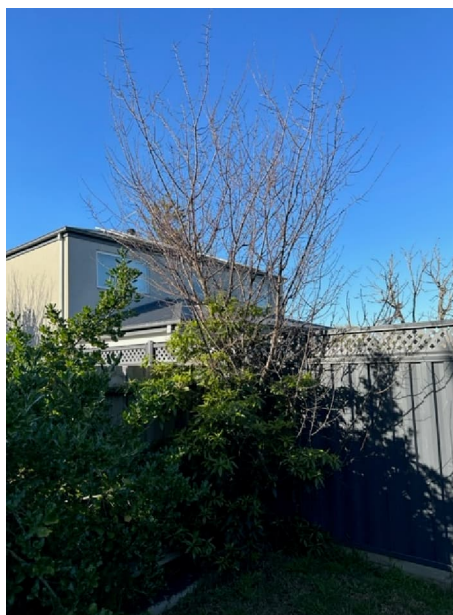
TREE #	9		
SPECIES	<i>Prunus</i> sp		
COMMON NAME	Plum		
TYPE	Exotic		
DBH (CM)	<10		
HEIGHT (M)	6		
SPREAD (M)	4		
STRUCTURE	Good		
HEALTH	Good		
AGE	Juvenile		
AMENITY VALUE	Low		
ULE (YRS)	15-40	TPZ (M)	2.0
IMPACT	Low- all works are outside the TPZ of this tree

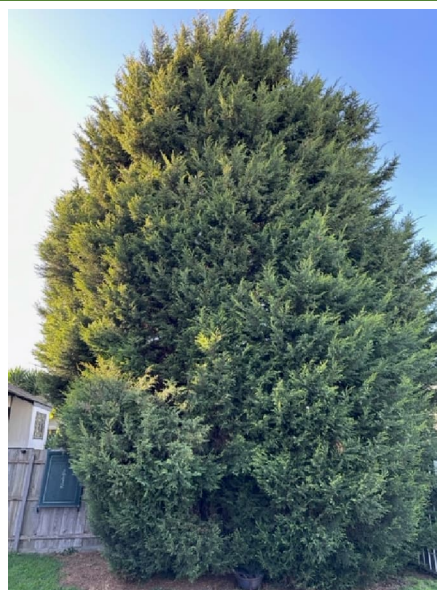
TREE #	10		
SPECIES	<i>Hesperocyparis macrocarpa</i>		
COMMON NAME	Monterey Cypress		
TYPE	Exotic		
DBH (CM)	~45		
HEIGHT (M)	11		
SPREAD (M)	9		
STRUCTURE	Good		
HEALTH	Good		
AGE	Mature		
AMENITY VALUE	Medium		
ULE (YRS)	40+	TPZ (M)	5.4
IMPACT	High- tree proposed to be removed for the development. Consent from the owner has been obtained for the removal of this tree.		
RECOMMENDATIONS	<p>A permit is required for the removal of this tree as it meets the definition of a significant tree under the City of Darebin 'Tree Protection Local Law'. Whilst this tree is exotic and of only medium amenity value, it is recommended that replanting occur within the development using tree species listed in the Darebin 'Sustainable Gardening Booklet'. This includes species such as:</p> <ul style="list-style-type: none"> <li>- Blackwood <i>Acacia melanoxylon</i></li> <li>- Lightwood <i>Acacia implexa</i></li> <li>- Drooping Sheoak <i>Allocasuarina verticillate</i></li> <li>- Muttonwood <i>Rapanea howittiana</i></li> <li>- Black Sheoak <i>Allocasuarina littoralis</i></li> </ul>

- Tree 10- A permit is required for the removal of this tree as it meets the definition of a significant tree under the City of Darebin 'Tree Protection Local Law'.  
Whilst this tree is exotic and of only medium amenity value, it is recommended that replanting occur within the development using tree species listed in the Darebin 'Sustainable Gardening Booklet'. This includes species such as:
