# MELBOURNE ARBORIST REPORTS

## Arboricultural Report Development Impact Assessment

**Site address:** 3 Waverley Avenue, Ivanhoe. VIC 3079

**Date of assessment:** 09 Feb 2023

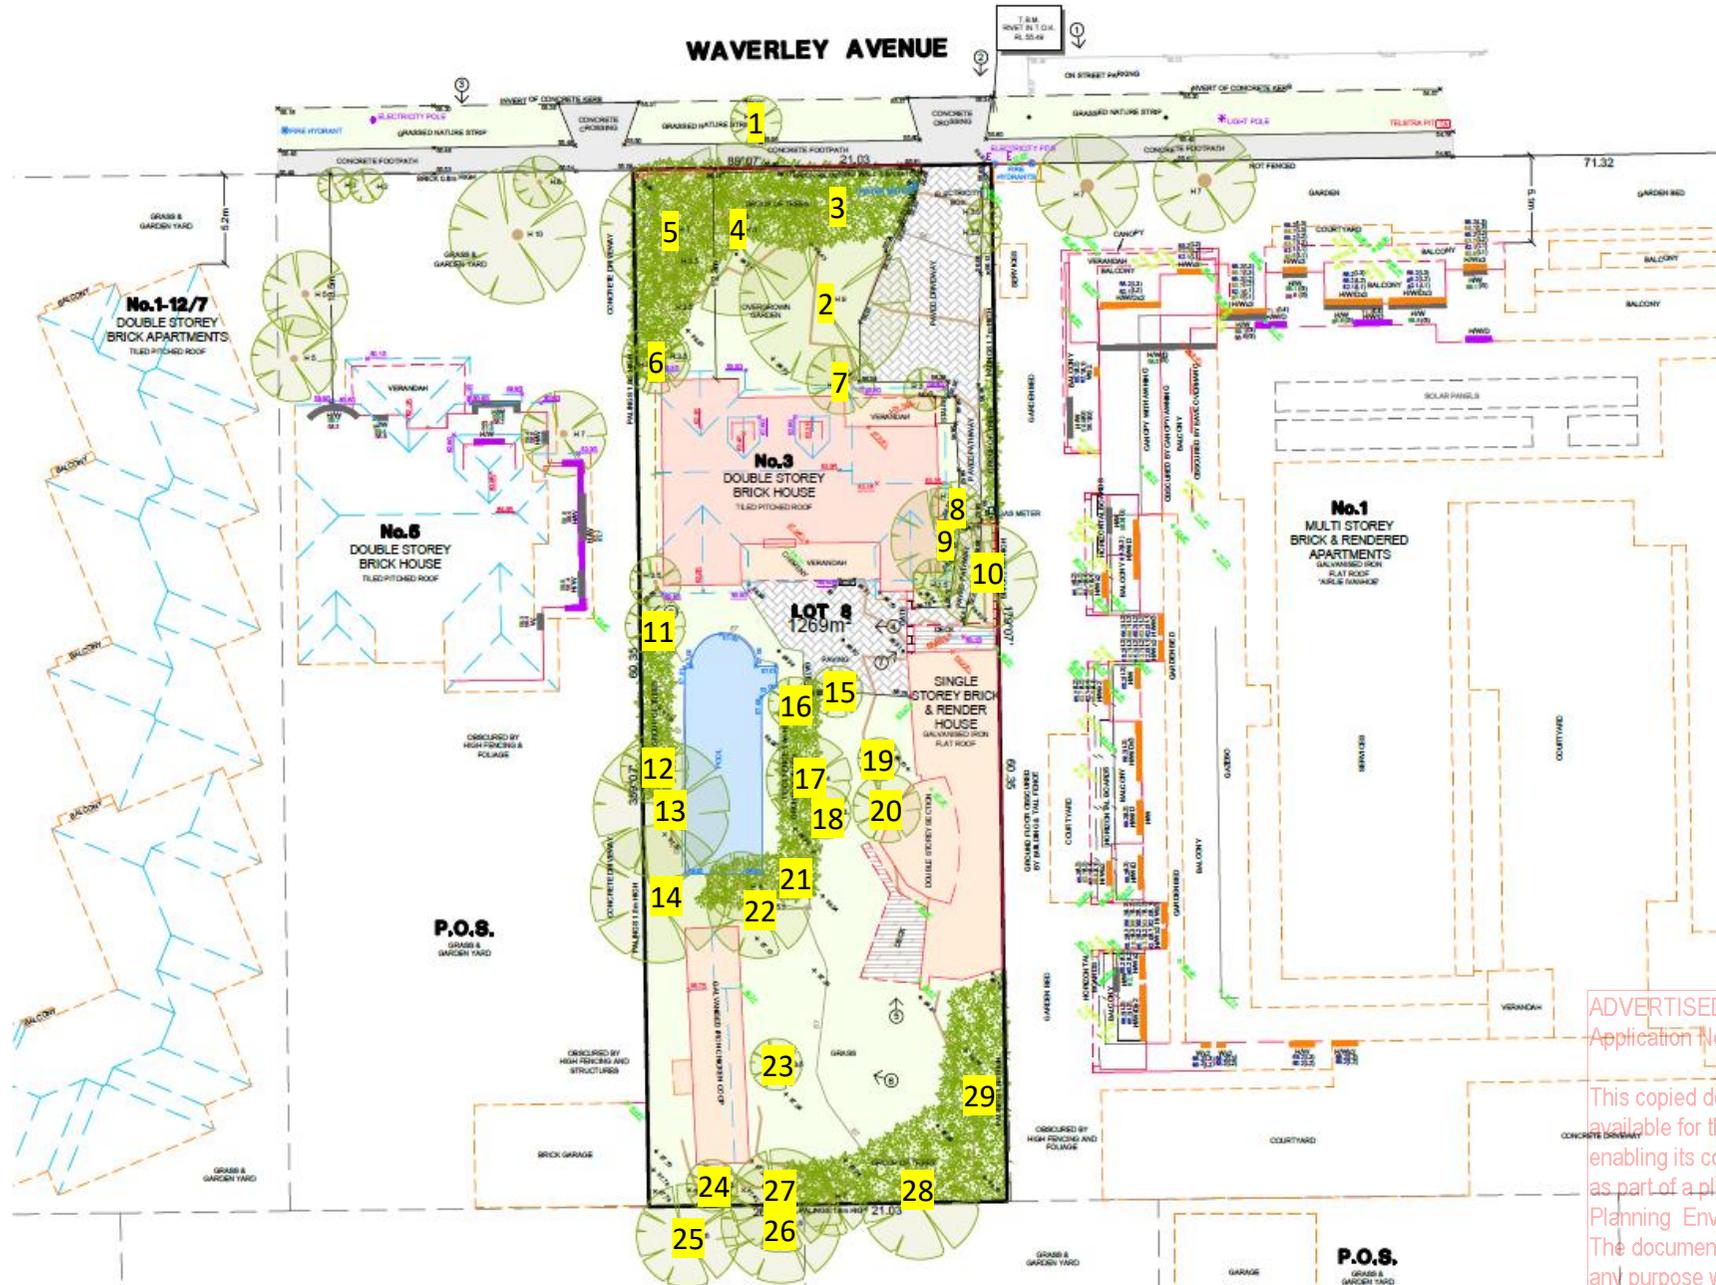
Figure 1 Feature survey prepared by JCA Land Consultants DWG: 3053511F1D 20/01/2023 shows tree locations and existing conditions

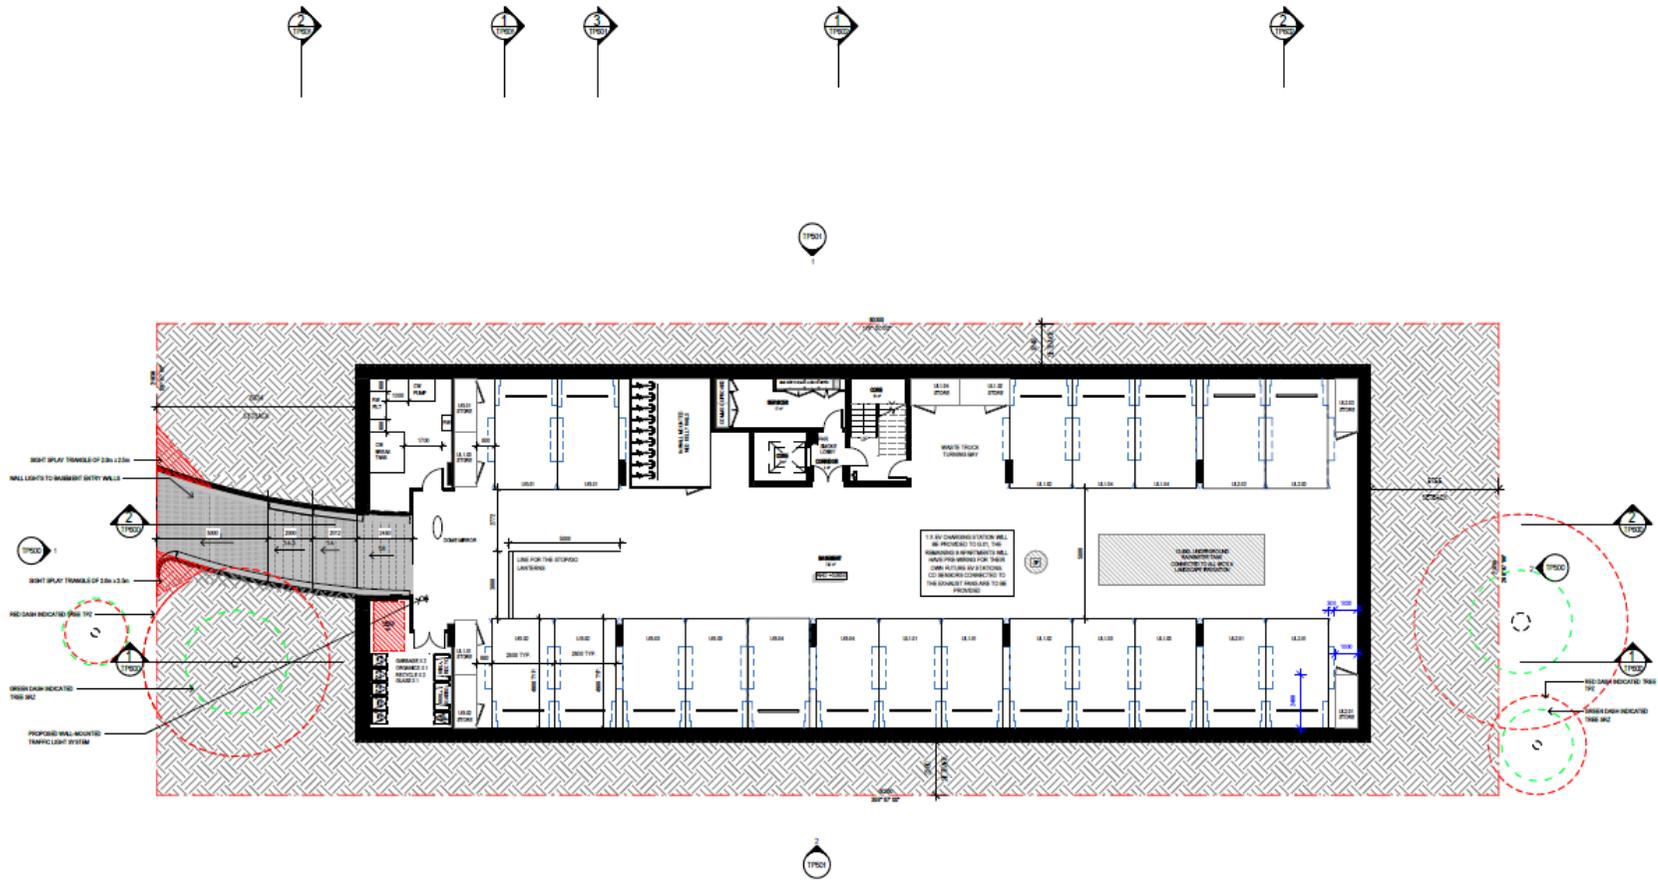
Figure 2 Proposed basement plan prepared by KUD

Proposed development plans shown in Figure 2 will require the removal of all trees onsite, except for tree 4 to be retained in the front setback.

Proposed plans to develop the subject site, as shown in Figure 2, will require the removal of all trees onsite, except for tree 4. In general, trees onsite were assessed as low retention value and should not be a constraint on the development design.

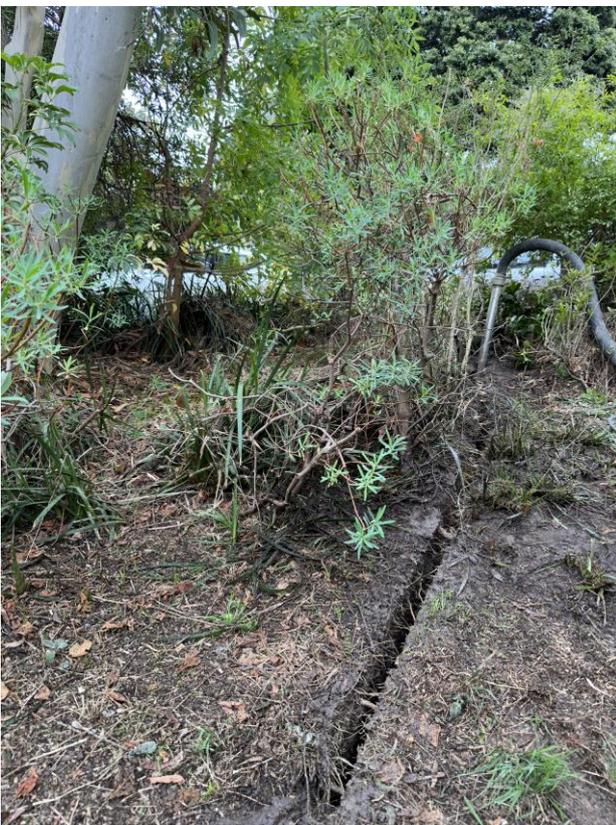
A non-destructive root investigation (NDRI) was completed on 05 May 2023, using hydro-excavation to establish a trench along the proposed basement ramp site cut. Trench depth was 500mm-700mm, no woody roots were found (Figures 25 & 26). Therefore, the proposed basement ramp will have no impact on the current condition of tree 4.

Figure 25 NDRI trench along proposed basement ramp in relation to tree 4

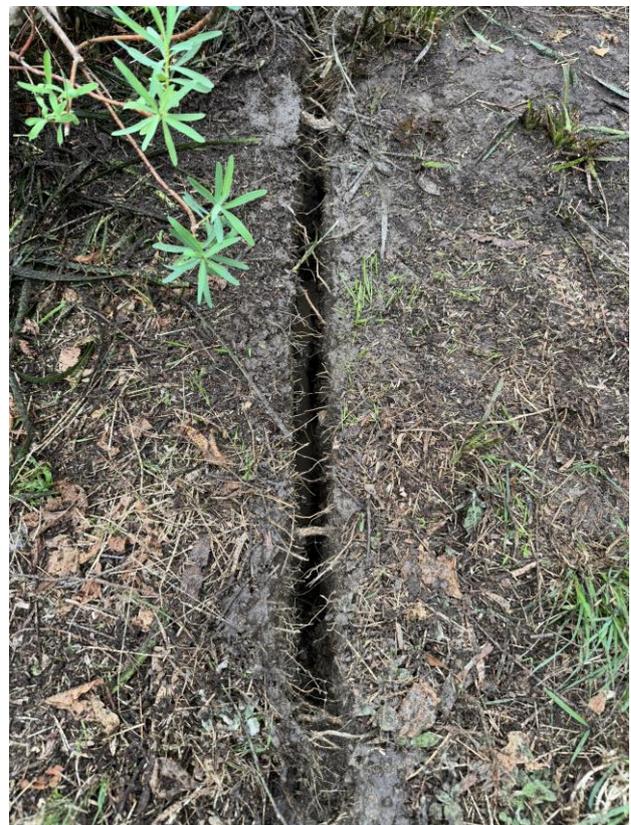
Figure 26 View into trench. No woody roots found. NB minor roots near surface originate from undergrowth
