## MELBOURNE ARBORIST REPORTS

# Arboricultural Report Development Impact Assessment

**Site address:** 8 Carpenter Street, Noble Park. VIC 3174

**Date of assessment:** 15 Sep 2023

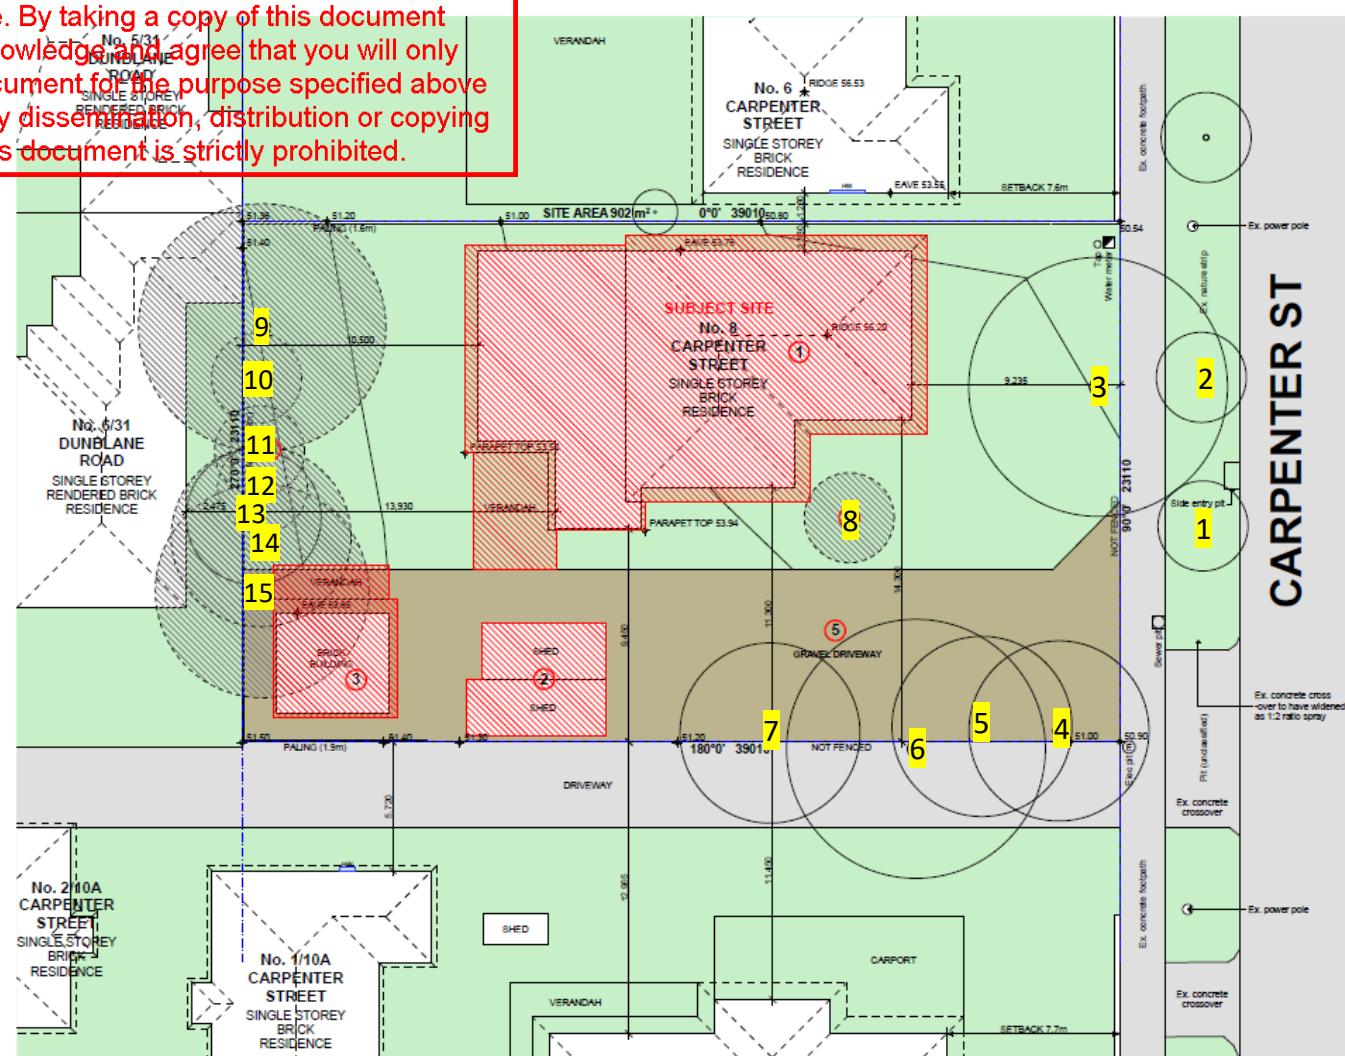
Figure 1 Existing site plan prepared by KX Architecture shows tree locations and existing site conditions

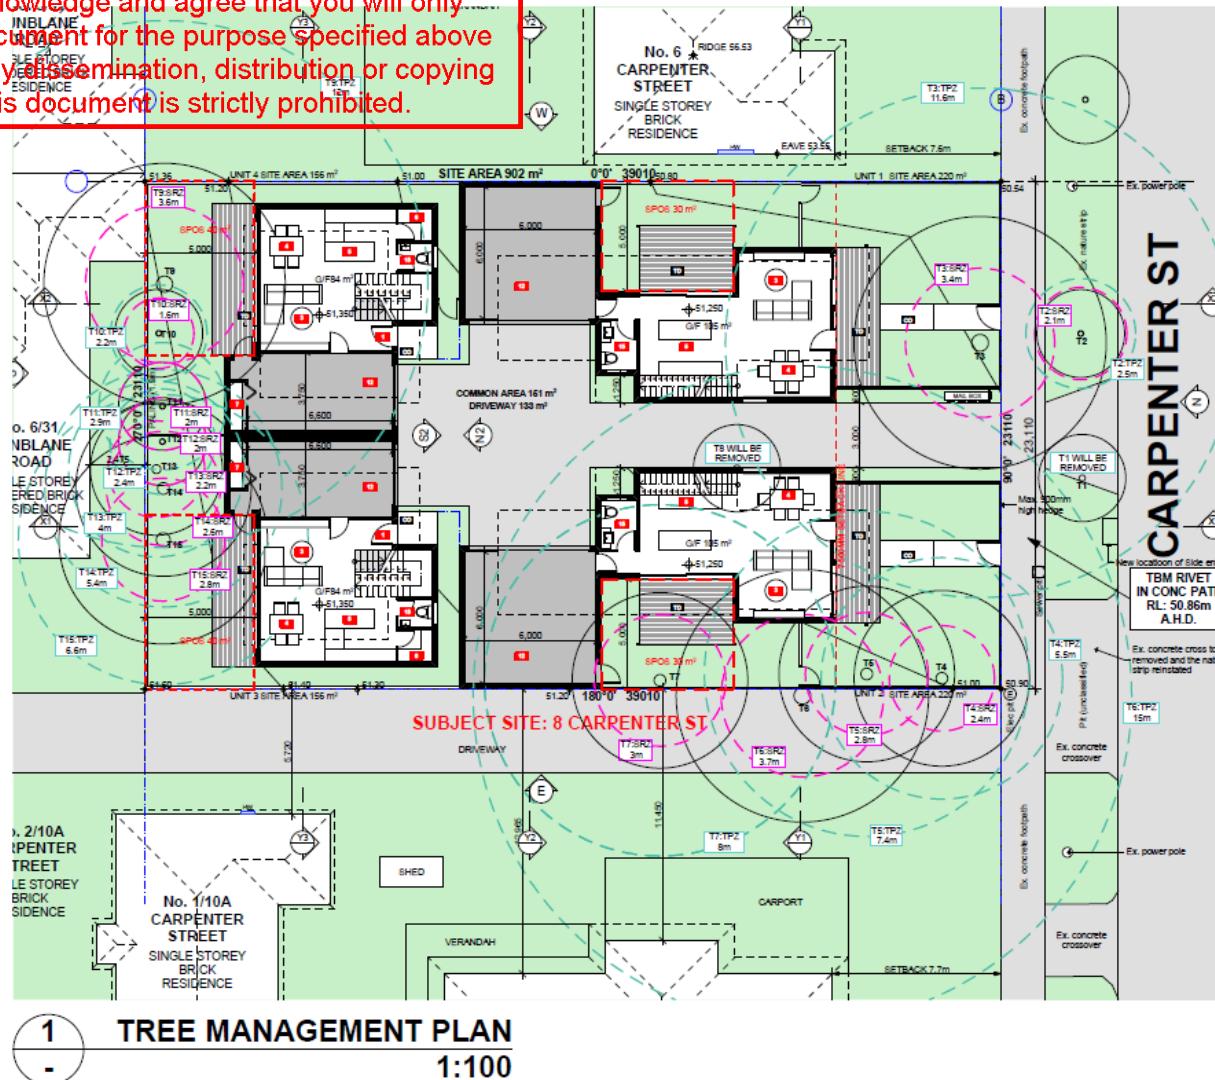
Figure 2 Proposed site plan prepared by KX Architecture shows proposed development layout, TPZs and SRZZs

Proposed development plans shown in Figure 2 will require the removal of trees 1, 3, 5-15 as detailed in table 2 below. Proposed plans show trees 3, 5-7, 9-15 being retained however, major TPZ encroachments will result for these trees which will necessitate their removal. Trees 9-15 were growing in close proximity to each other and should therefore be managed as group.

Proposed plans allow for the successful retention of trees 2 and 4 with zero or minor TPZ encroachment.

Tree 4 was a moderate retention value tree located towards the front of the site. Proposed plans show a minor TPZ encroachment by the front landing of the proposed north-east unit.

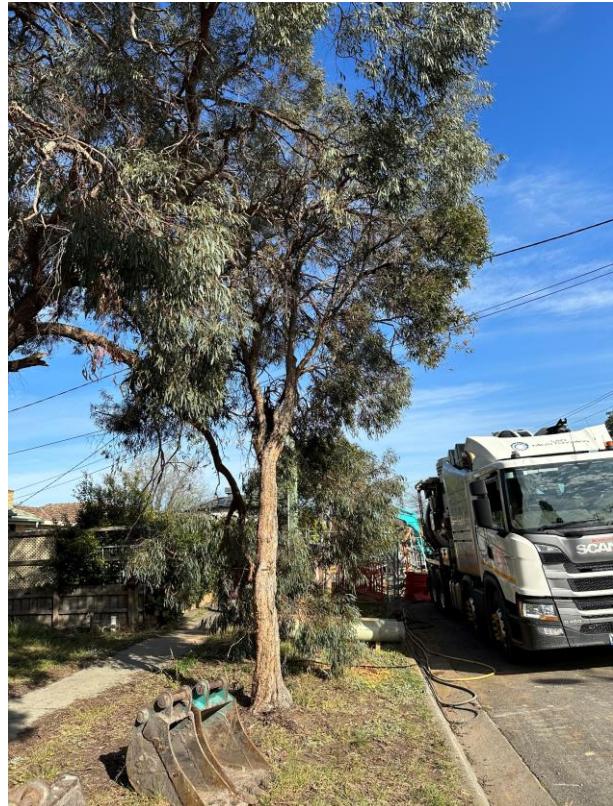
Figure 4 Tree 2

Tree 2 was a small street tree located on the nature strip in front of the site. Proposed plans show no encroachment of the tree 2 TPZ.
